**EPA Region 10
PCB Compliance Inspection Report**

Facility Name: Rainier Commons, LLC

Inspection Date: September 1, 2009

Inspection Type: Sampling

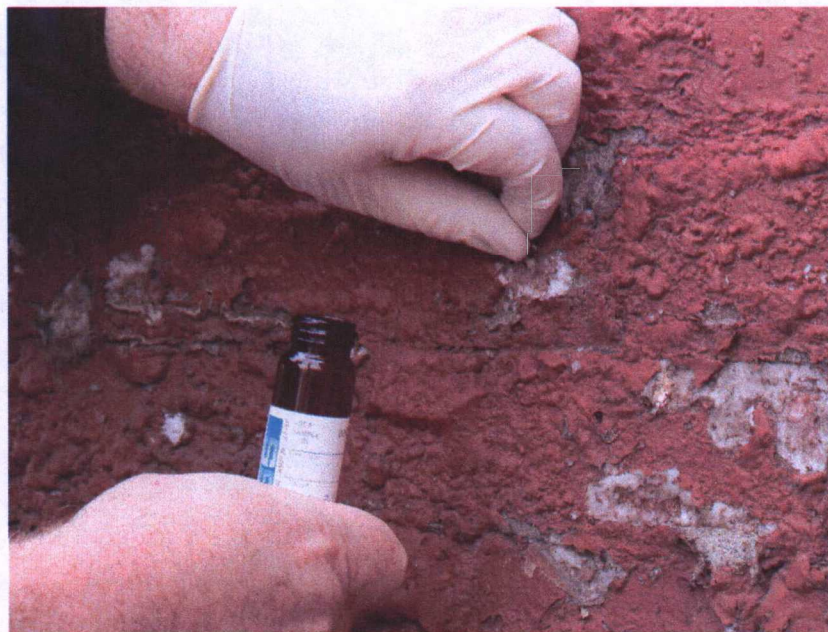
Description: Sample 09354101 was collected from the lower section of the smokestack. This sample is approximately 12 feet above street level. The total PCBs in this sample are 390 ppm.

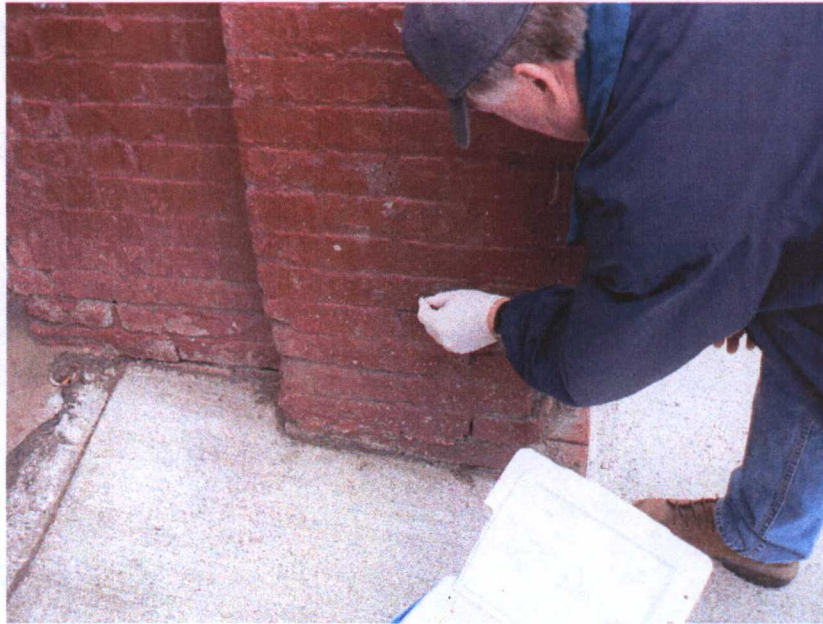
Photo No: P101131

Description: Northwest corner of Building 12. This is the location of sample 09354102. To the left is the doorway into the PCB storage for disposal unit. The total PCBs in the paint sample are 11.2 ppm.

Direction: Northwest corner of Building 12 – Steam Plant Row.

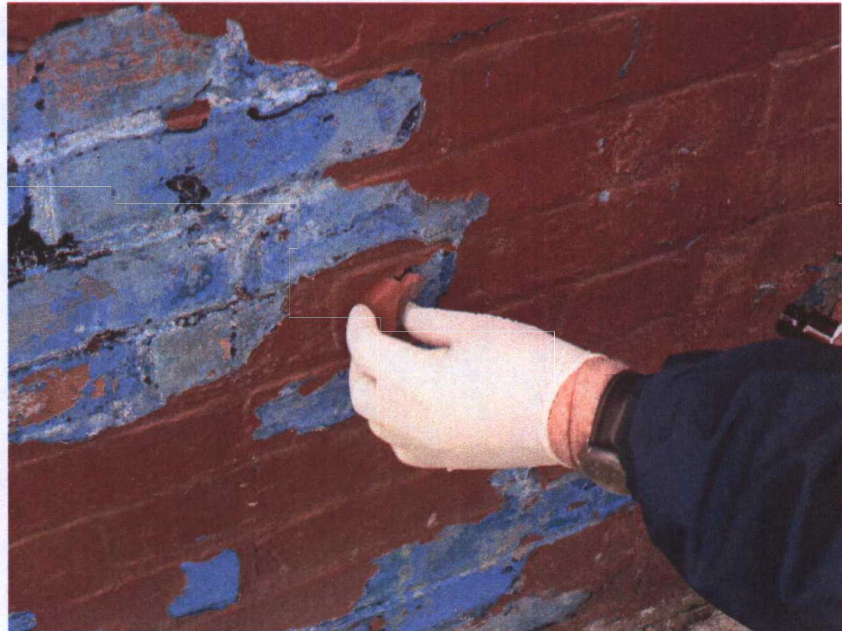
Description: : Northwest corner of Building 12. This is the location of sample 09354103. The total PCBs found in the paint sample are 19.2 ppm.

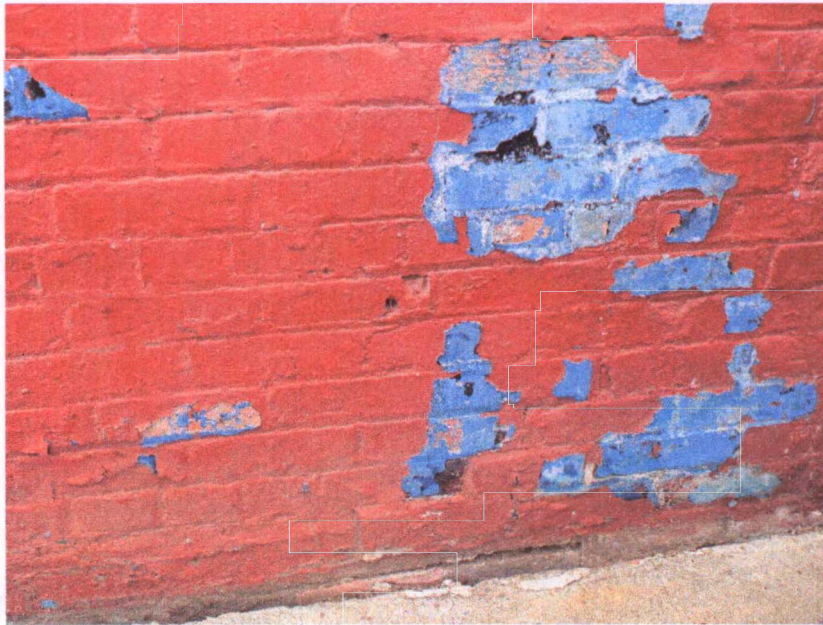
Photo No: P101135

Description: Location of sample 09354103. The paint colors under the outer coat of red vary from black to blue. The black paint is below the blue paint seen in the photograph. This sample is a mixture of all the colors. The total PCBs found in the sample are 19.2 ppm.

Direction: West wall of Building 12 – Steam Plant Row.

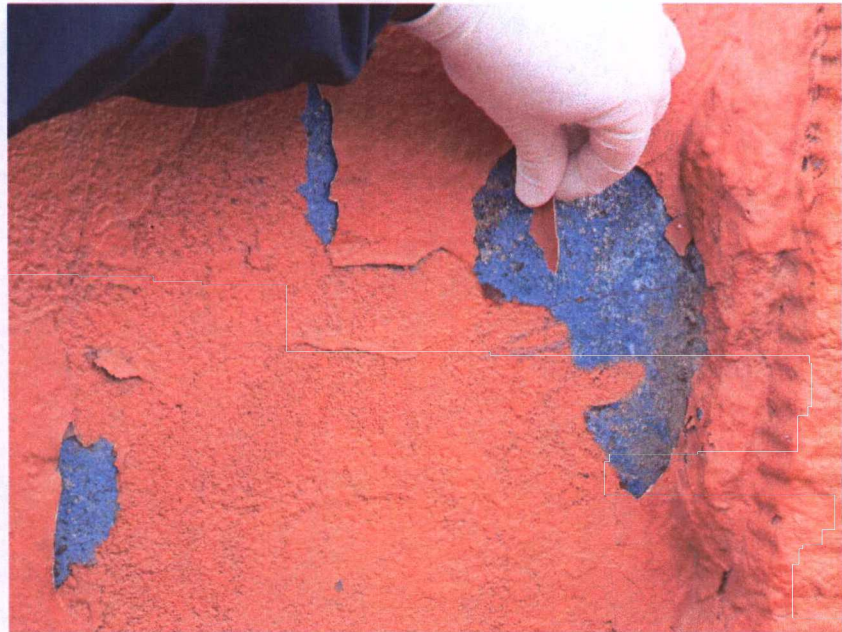
Description: Location of sample 09354104. The under coats of paint range from orange, beige to blue. The sample is a mixture of all of the colors of paint and the total PCBs are 10,200 ppm

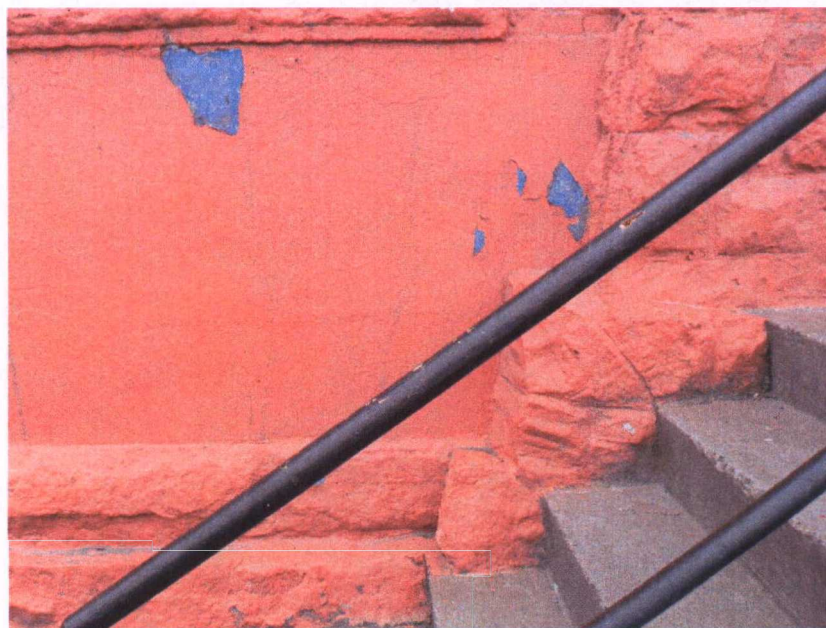
Photo No: P101137

Description: Additional view of location of sample 09354104

Direction: Steps to the loading dock at Building 9 – Tully’s Factory.

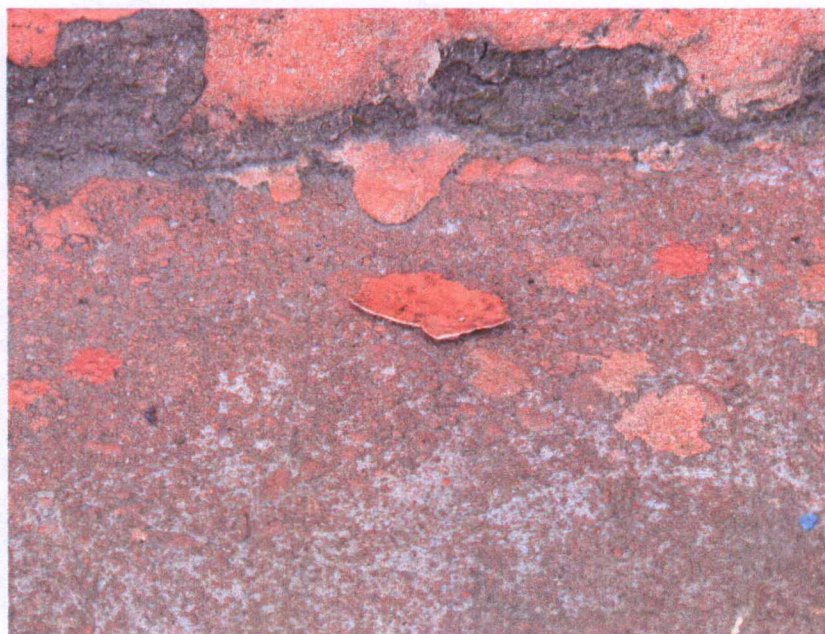
Description: A fallen paint chip about the size of a US Quarter.

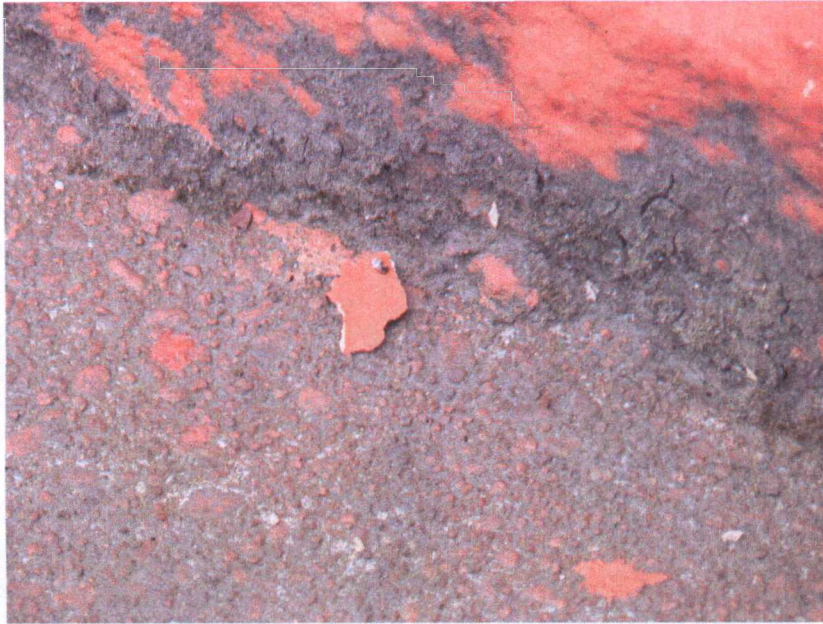
Photo No: P101139

Description: An additional fallen paint chip about the size of a US Quarter.

Direction: Ledge on the west wall of building 9, north of loading dock – Tully's Factory.

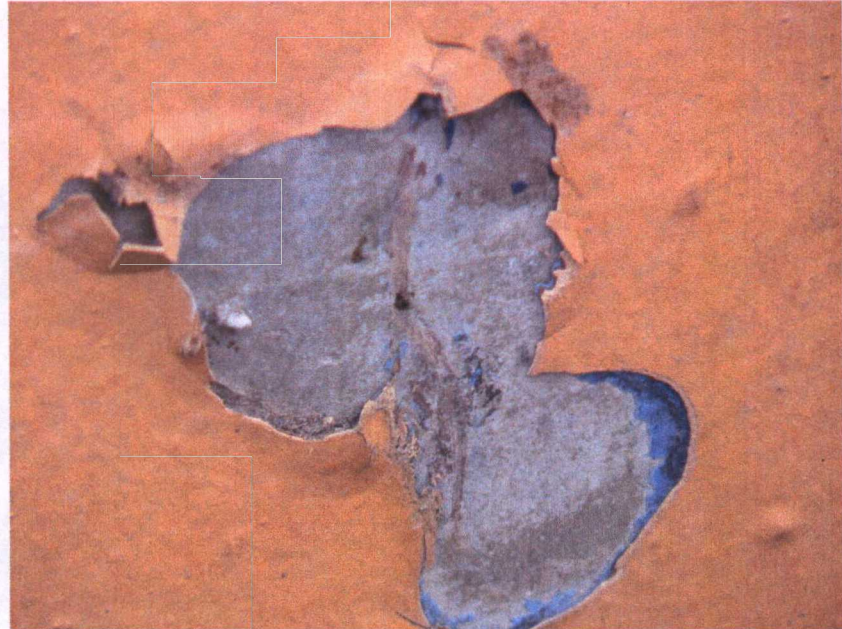
Description: Location of sample 09354105. The under coats of paint is a metal metallic in color. The concert wall is exposed here. The total PCB found in this sample is 12,400 ppm. The sample is a mixtures of the metal metallic color, the blue undercoat and the orange over coat

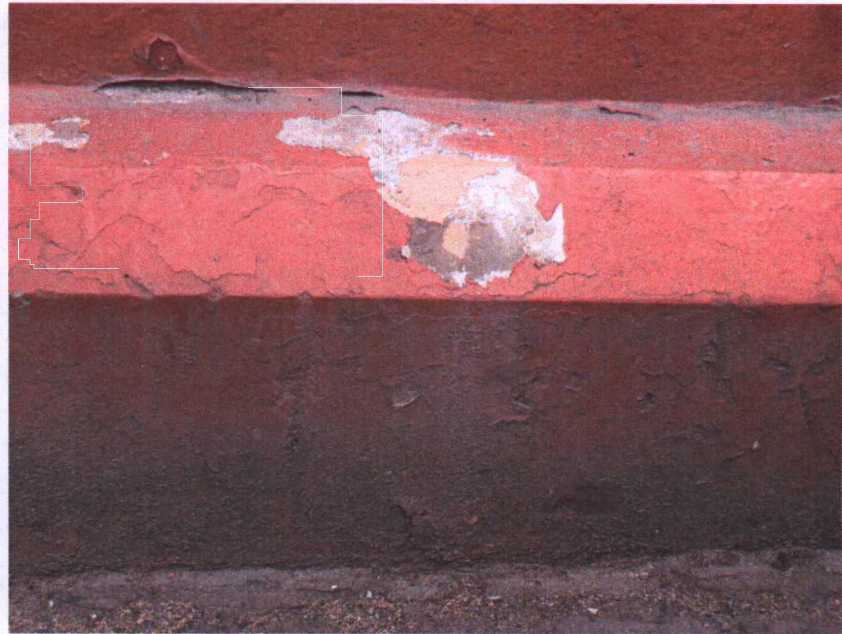
Description: Location of sample 09354106. The under coating are white and beige in color. The concert is exposed under the white paint. The PCB concentration in the sample is 690 ppm.

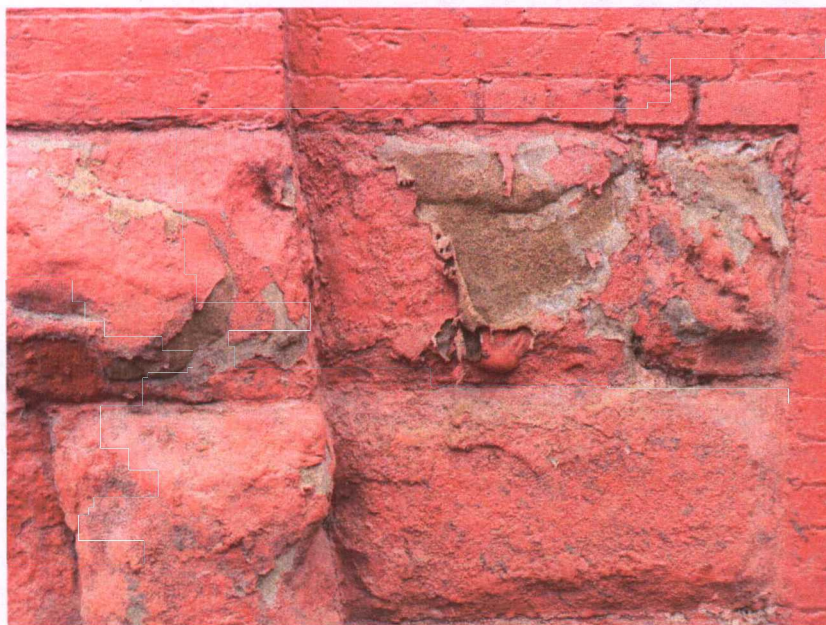
Photo No: P101143

Description: Location of sample 09354107. The rock used to build the wall near the stairs is exposed and breaks up easily when touched.

Direction: West wall of Building 5A, next to stairs – Brew Kettle Block.

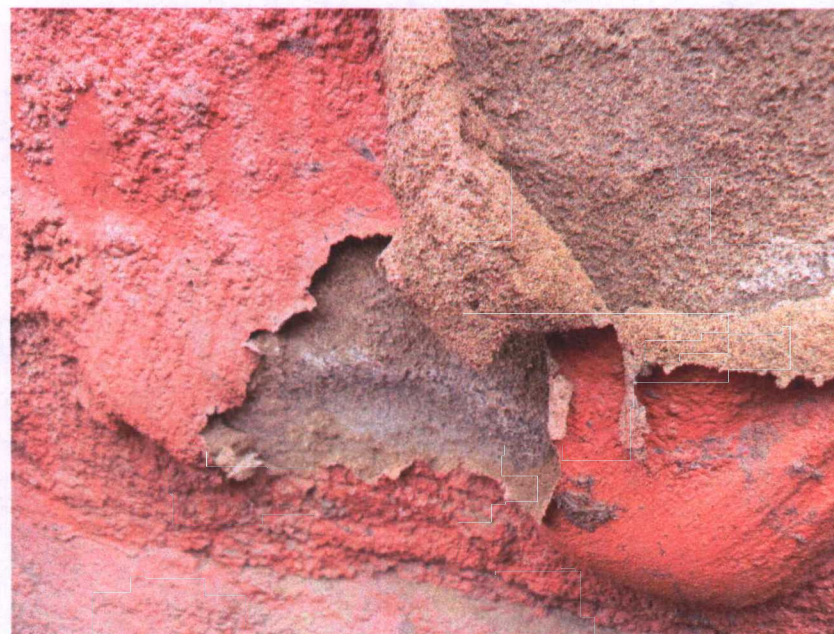
Description: Location of sample 09354107. The rock used to build the wall near the stairs is exposed and breaks up easily when touched. The concentration of PCB in the sample is 6.5 ppm.

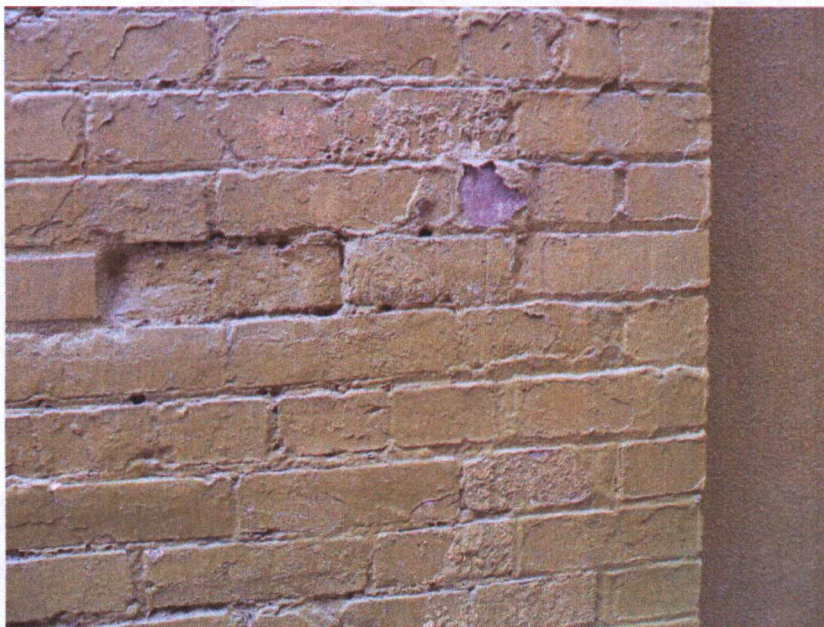
Photo No: P101145

Description: Location of sample 09354108. This is the west wall of Building 6, just north of the entry door (See 101146). The sample is a mixture of paint colors; green and purple.

Direction: West wall of Building 6 – Brew Kettle Block

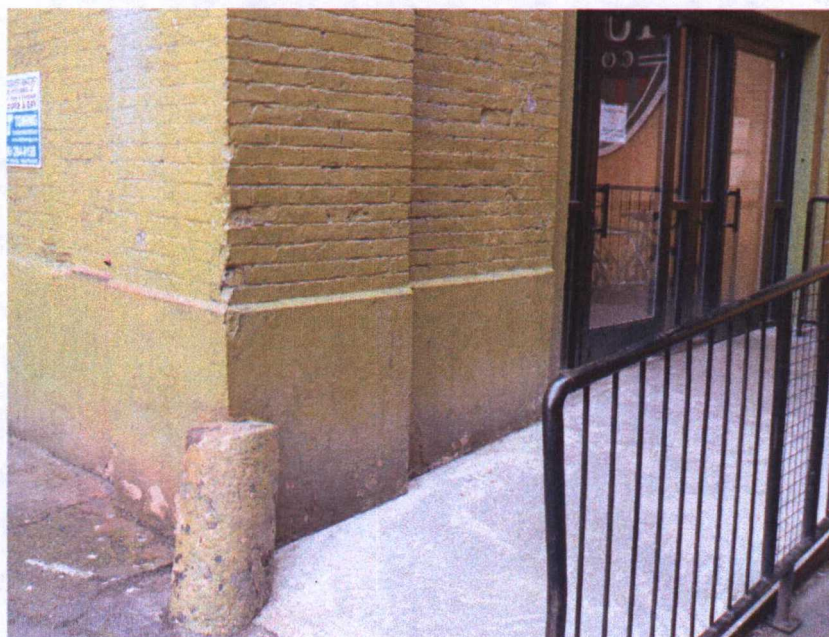
Description: Paint chips on the walkway leading to the door were combined with the flake paint sample taken from the location see in Photograph 101145. The total PCB concentration is 18,000 ppm.

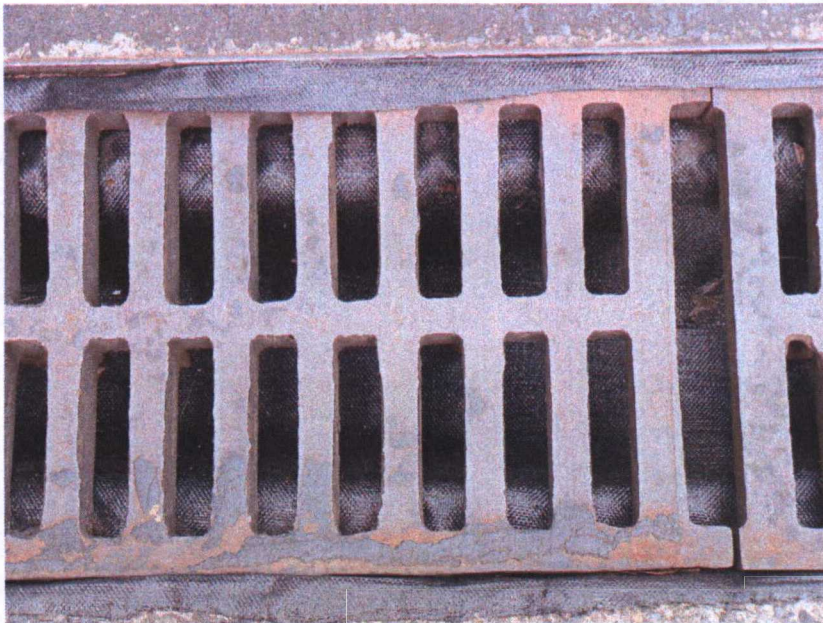
Photo No: P101147

Description: The catch basins in the ally behind Building 13 did not have a sufficient amount of debris for collecting. This is the same catch basin EPA sampled in March 2009.

Direction: Catch basin between Buildings 3 and 13 – Steam Plant Row.

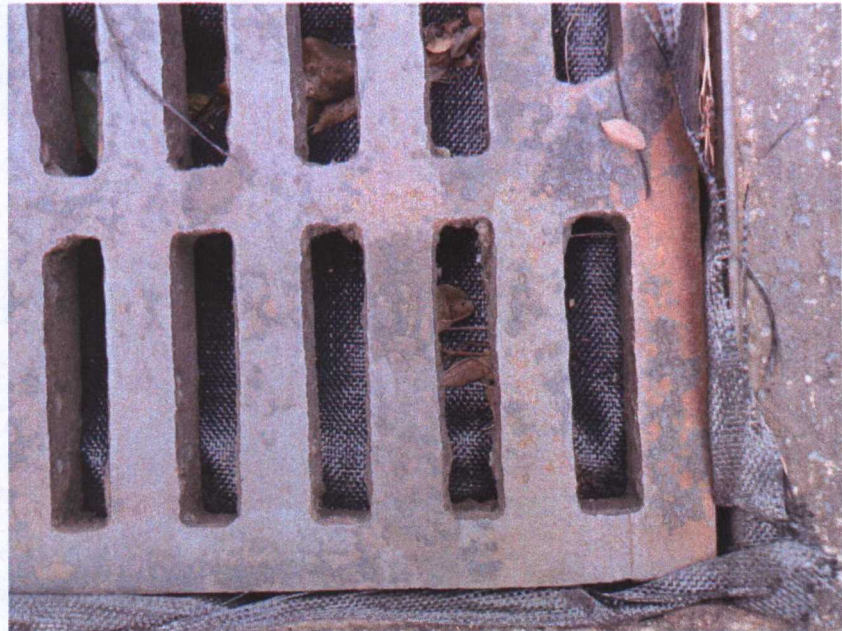
Description: Close-up of the new sock inside the catch basin.

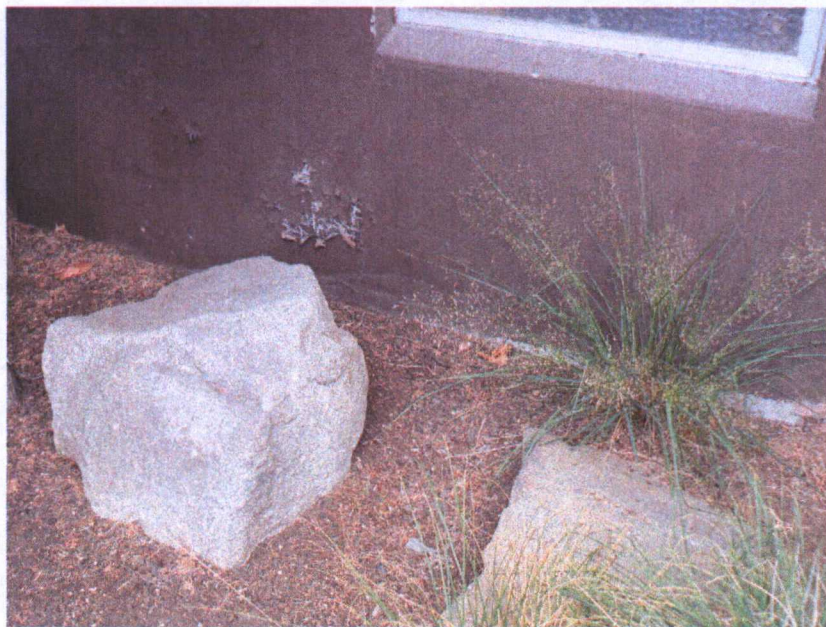
Photo No: P101150

Description: The coats of paint are brown over black and tan or beige. This is the location of sample 09354109.

Direction: Building 1, west wall, north of entry – Tully's Business Center.

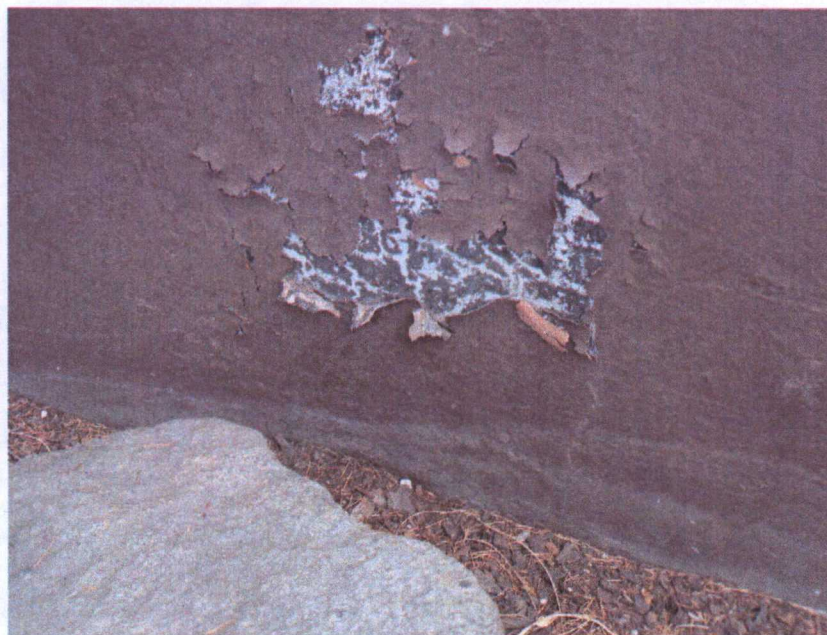
Description: The coats of paint are brown over black and tan or beige. No PCB were detected in this sample.

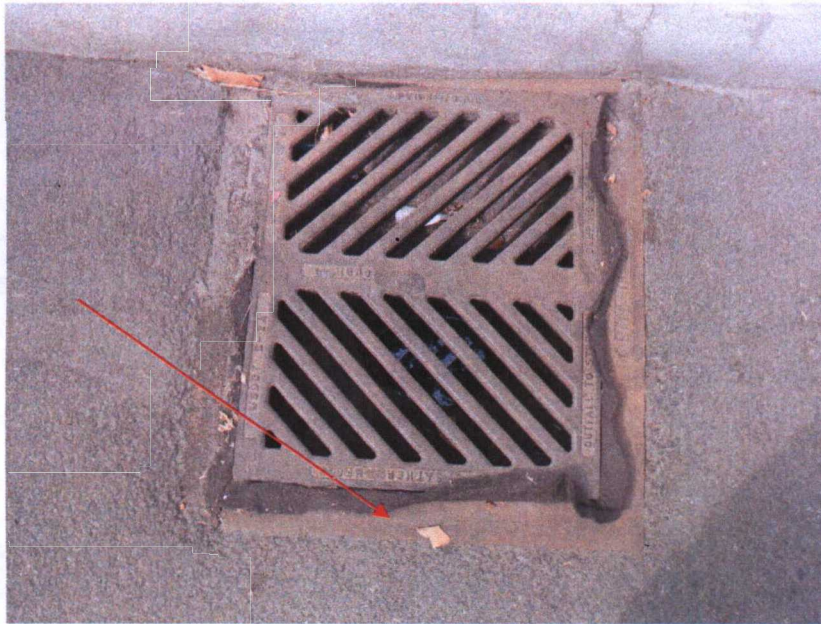
Photo No: P101152

Description: Paint chips on the edge of catch basin on the east road behind building 1. The paint is a tan or darker beige. The color of the paint chip is similar to the beige seen on Buildings 1 and 3.

Direction: East road between the Freeway and Building 1 – behind – Tully's Business Center.

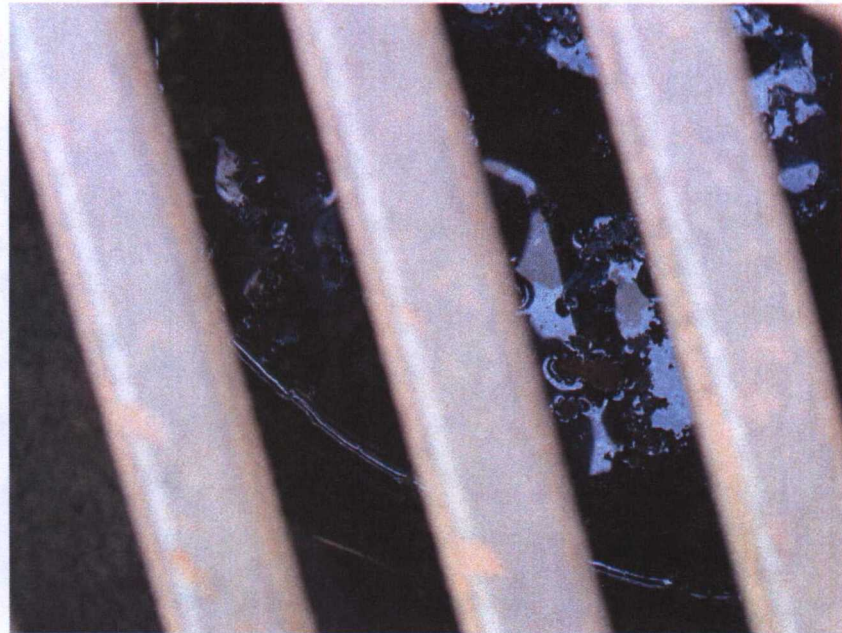
Description: This is a close-up of the sock and catch basin on the west side of Building 1. This is rainwater from earlier today. There was no debris in the sock.

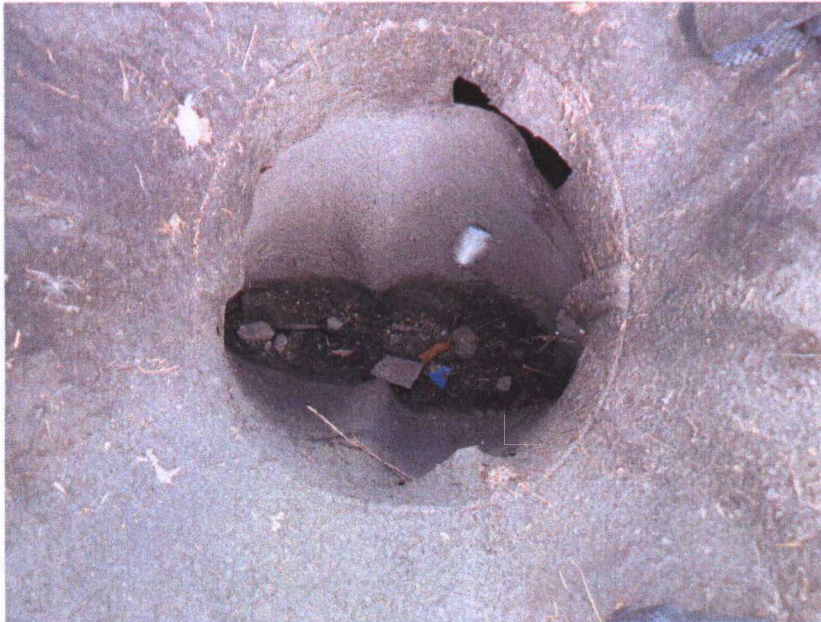
Photo No: P101156

Description: Catch basin east of Building 4. There is a little debris in the sock, but no paint chips are seen. The catch basin is up-hill from the Rainier Commons Building 4.

Direction: East of Building 4, in the road between the I-5 Freeway and Building 4 – Brew Kellte Block.

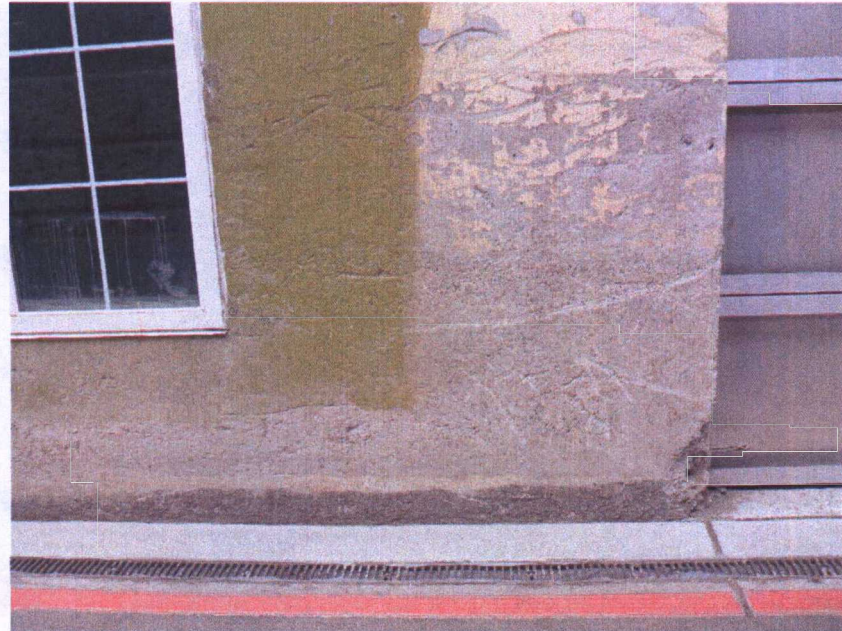
Description: Location of sample 09354110. This sample of paint was not covered by paint that had been applied after Rainier Commons, LLC purchased the property. The paint sample is two colors of beige. The total PCBs are 9.9 ppm

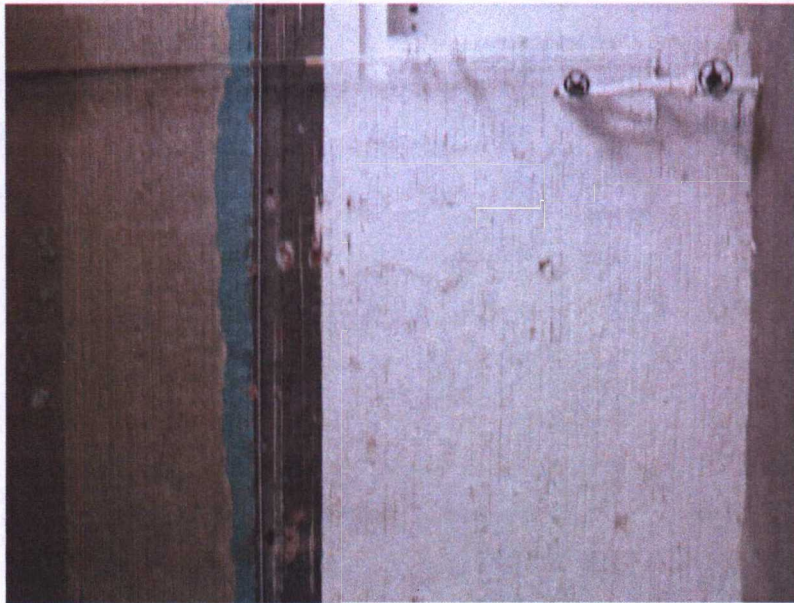
Photo No: P101158

Description: White wall inside the PCB Storage for Disposal Building.

Direction: Inside Building 12, north wall –
Inside the PCB Storage for Disposal Building.

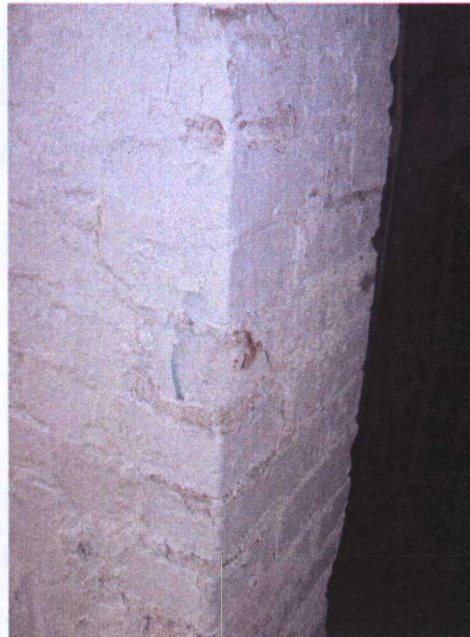
Description: Location of sample 09354111. The paint is white and the under coats are also white. Total PCBs are 16.1 ppm.

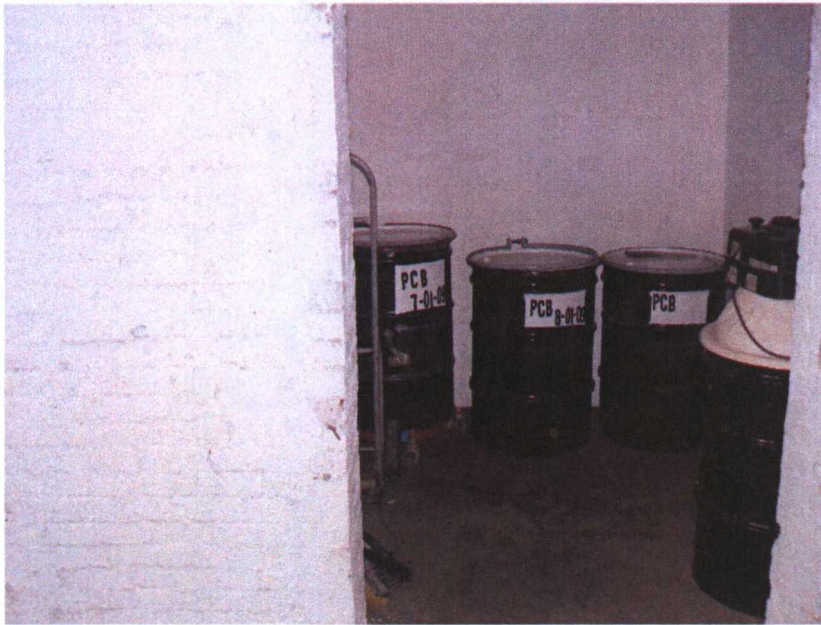
Photo No: P101160

Description: A little cove on the north wall of Building 12. All of the containers with debris picked up around the Old Brewery is marked with a date.

Direction: Inside Building 12, ground floor, north wall – Inside the PCB Storage for Disposal Building.

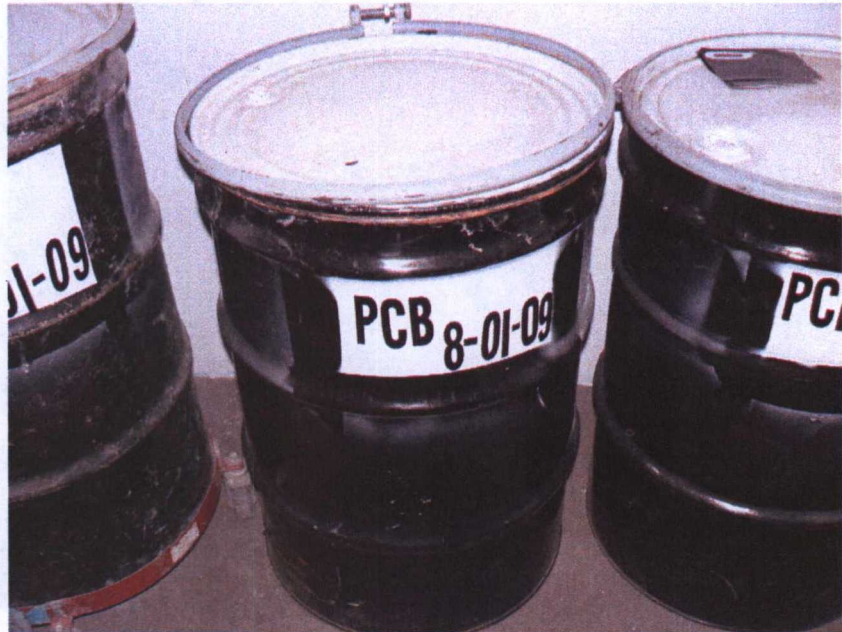
Description: The date on the containers is the starting date employees used to store contaminated debris that contains paint chips cleaned up around the Old Brewery.

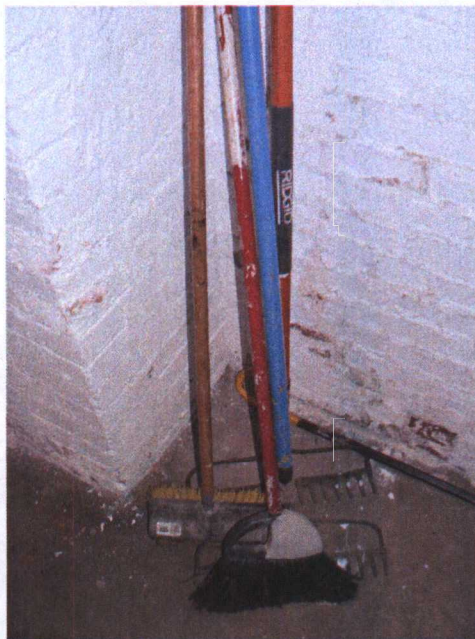
Photo No: P101162

Description: Brooms and rakes used to clean up paint chips at the Rainier Commons.

Direction: West wall of Building 12 – Inside the PCB Storage for Disposal Building.

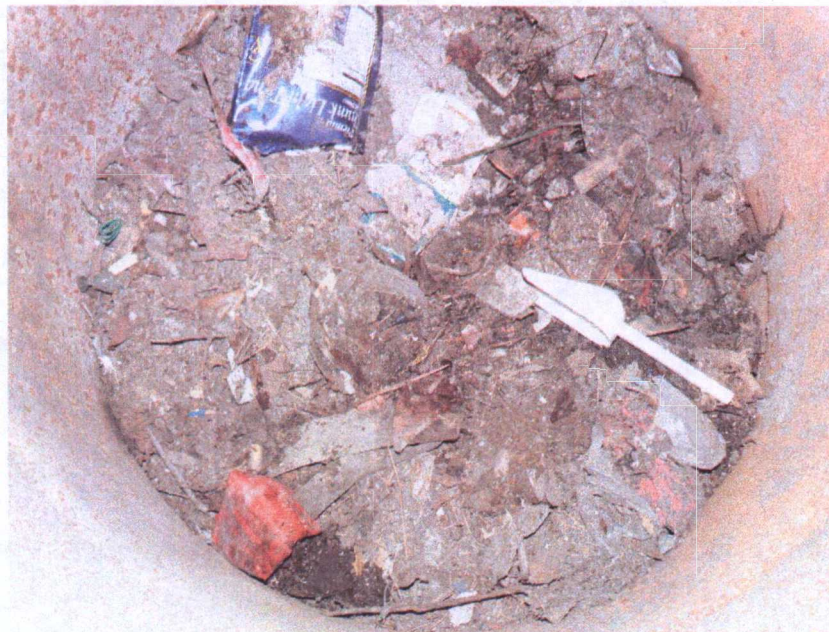
Description: Material inside the drum with the out of service date of 07/1/09. This is also the location of sample 09354112. PCBs in the sample total 5.5 ppm.
